LNG Tanker Incident – Nanutarra Jan 2018

Incident Overview

Incident Title	LNG Trailer Roll Over
Location	North West Coastal Highway, 20km south of Nanutarra Roadhouse, 1330km North of Perth
Date & Time of Incident	8/01/2018 ~ 20:10
Type of Incident	Motor Vehicle Incident, loss of containment and fire
Incident Summary	EVOL LNG tanker combination involved in traffic incident. Rear LNG trailer loss of containment resulting in localised fire. Lead LNG tanker impacted with resultant minor leak. Secondary vehicle (prime mover and low loader) impacted by collision and resultant fire.
Actual Consequence	Equipment Damage / Loss of Containment (18.14t)
Potential Consequence	Permanent Disability / Fatality Larger Stock Loss / Larger Fire

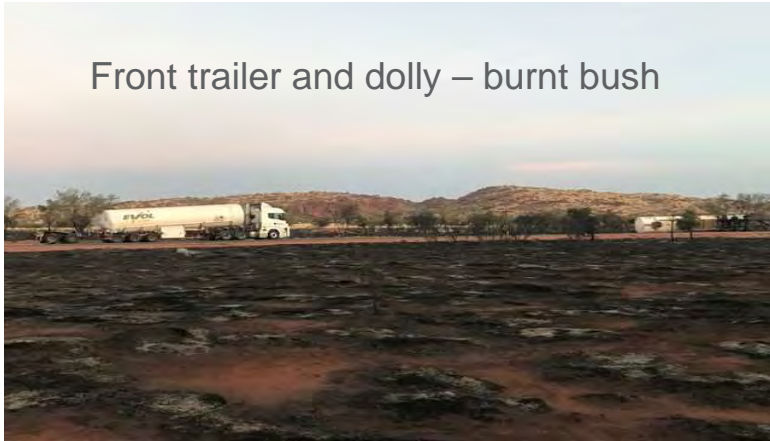
Front trailer and dolly – burnt bush

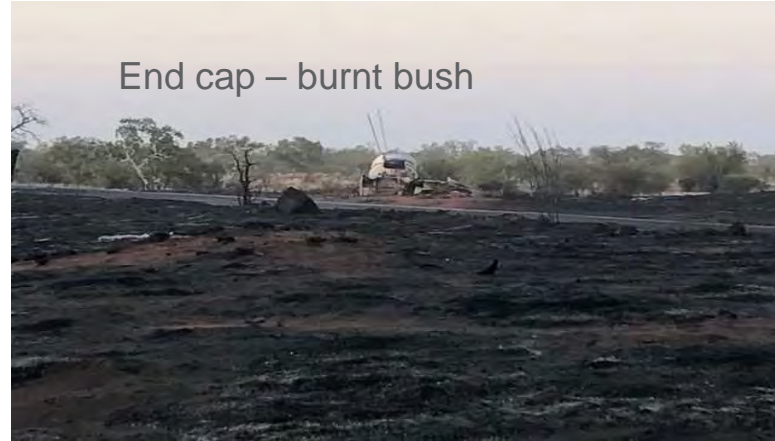
End cap – burnt bush

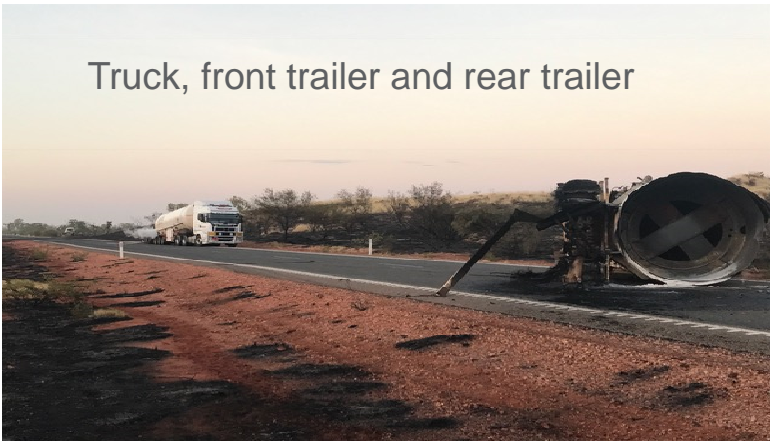
Truck, front trailer and rear trailer

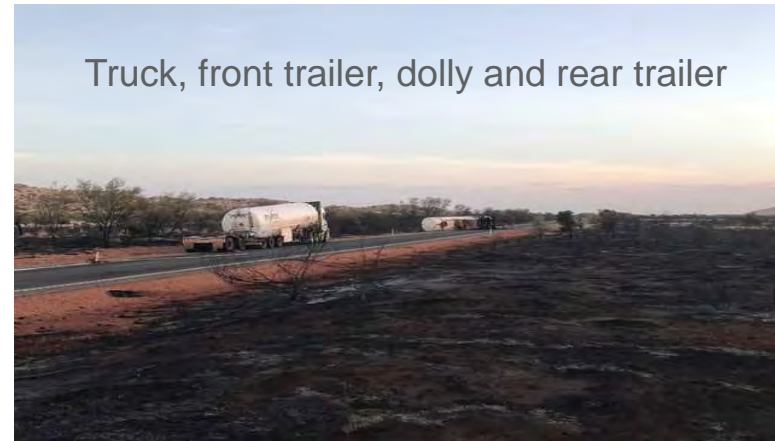
Truck, front trailer, dolly and rear trailer

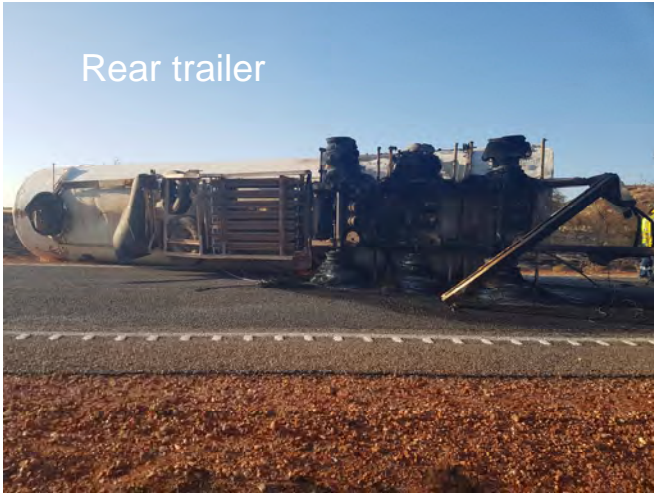
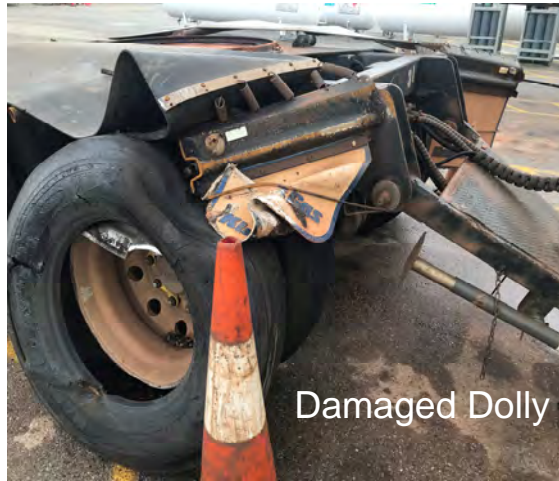
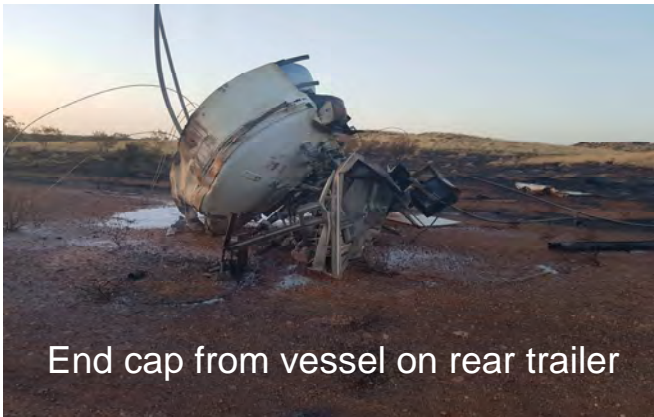
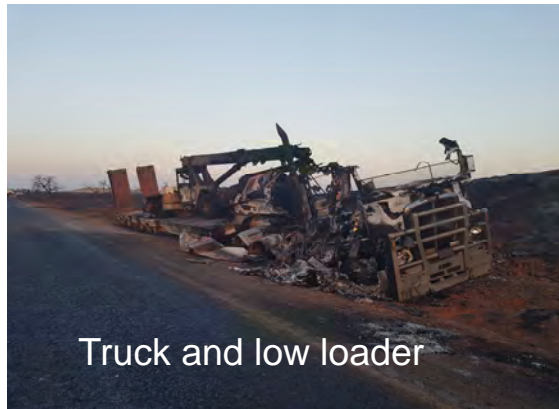
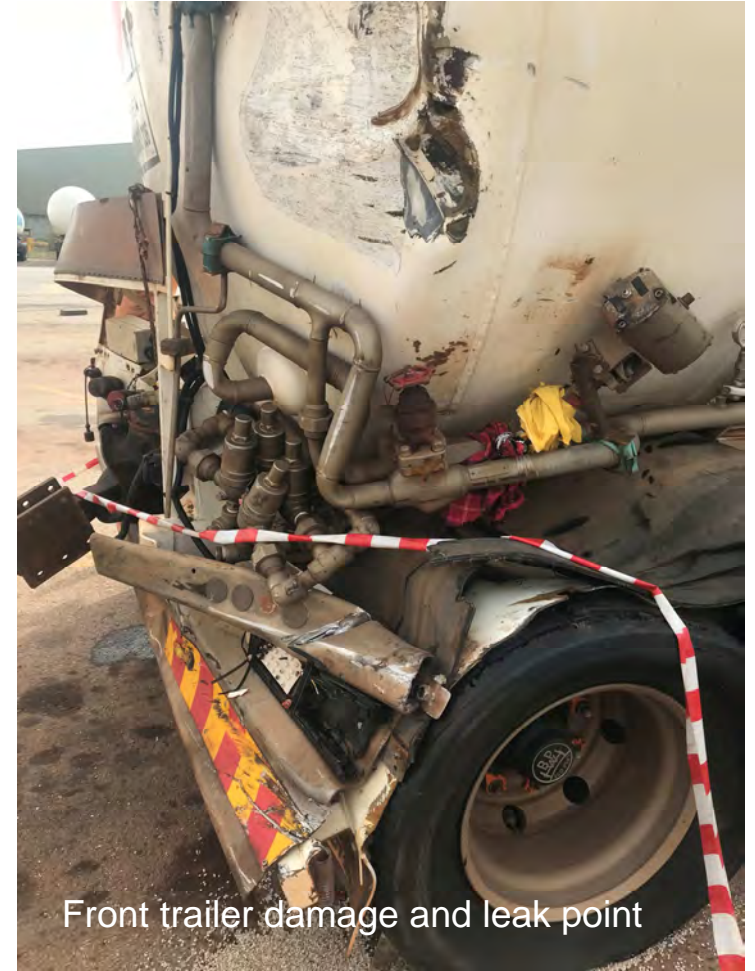
Equipment Damage

Contact point was 30cm in front of weld, shaped like the culvert on a pole vault track, with the perpendicular shear occurring 5cm from the weld

- Under high magnification confirmed slight deformation of the microstructure indicating a ductile fracture
- And indications the grains had been sensitized by significant force
